# CHARTING A NEW COURSE FOR THE *MONITOR*

**A Comprehensive, Long Range Preservation Plan  
With Options for Management, Stabilization,  
Preservation, Recovery, Conservation and  
Exhibition of Materials and Artifacts  
from the *Monitor* National Marine Sanctuary**

April 1998

**U.S. DEPARTMENT OF COMMERCE  
NATIONAL OCEANIC AND ATMOSPHERIC ADMINISTRATION  
National Ocean Service  
Office of Ocean and Coastal Resource Management  
Sanctuaries and Reserves Division**

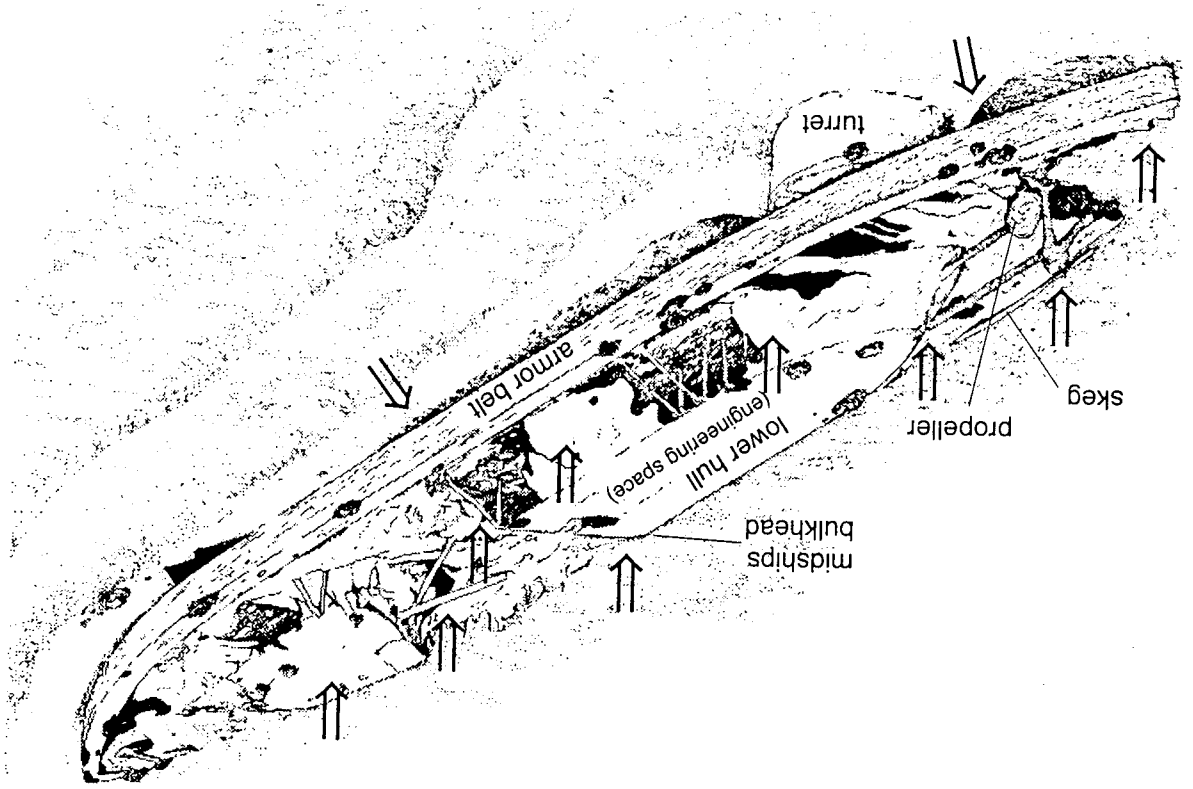
Since 1991 significant changes have been noted at the Sanctuary by NOAA and NOAA-permitted researchers (Figures 6 and 7). Since the *Monitor* is an iron ship lying in a high-current, high-temperature, saltwater environment, its iron components are continually being reduced by oxidation and electrochemical corrosion. Until 1990 researchers assumed that the deterioration of the *Monitor*'s hull and contents was a relatively slow but continual process; various efforts were made to predict a rate of metal loss for its iron hull and armor. Analysis of a hull plate recovered in 1977 revealed that the plate had lost 78% of its thickness during its 116 years of immersion in the ocean (Beachem, et al. 1979). As one reviewer pointed out, calculations based on that single plate sample indicate that the *Monitor*'s plating may now retain only 9% of its original thickness. Structural framing elements can be expected to

Figure 6. The hull of the *Monitor* as it appeared in 1974; the bow faces West. Arrows indicate key areas of recent deterioration (NOAA illustration).

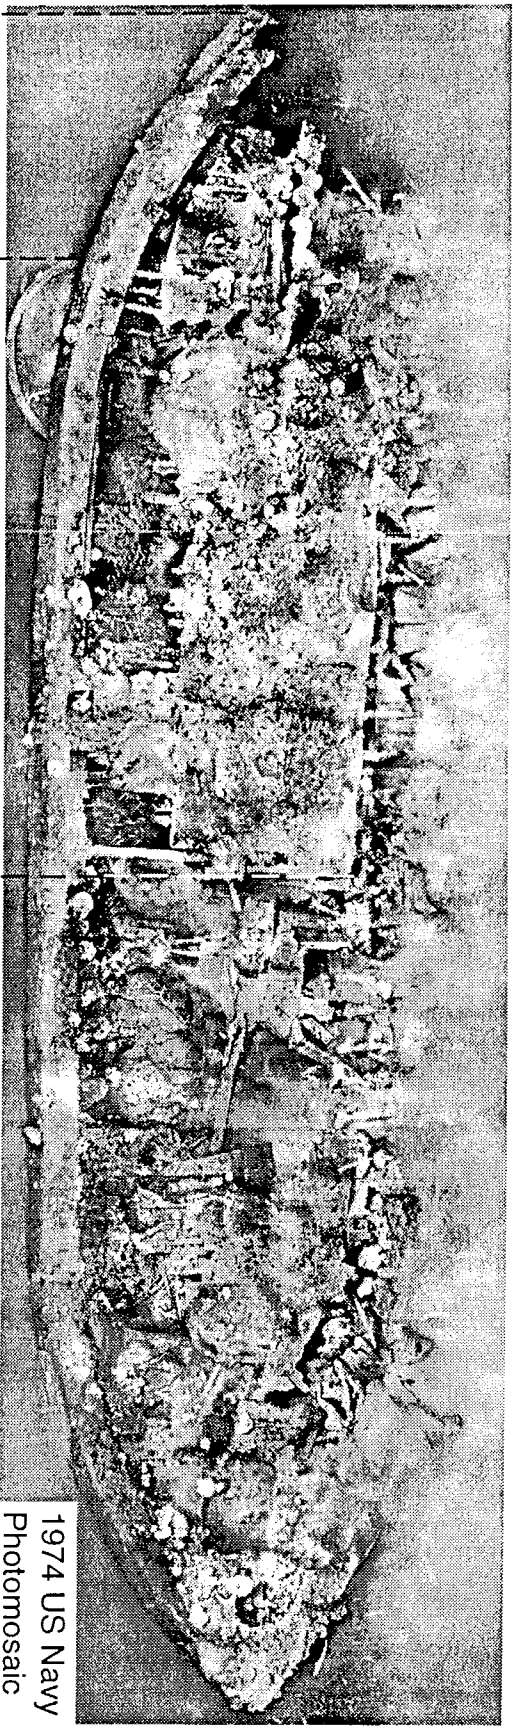
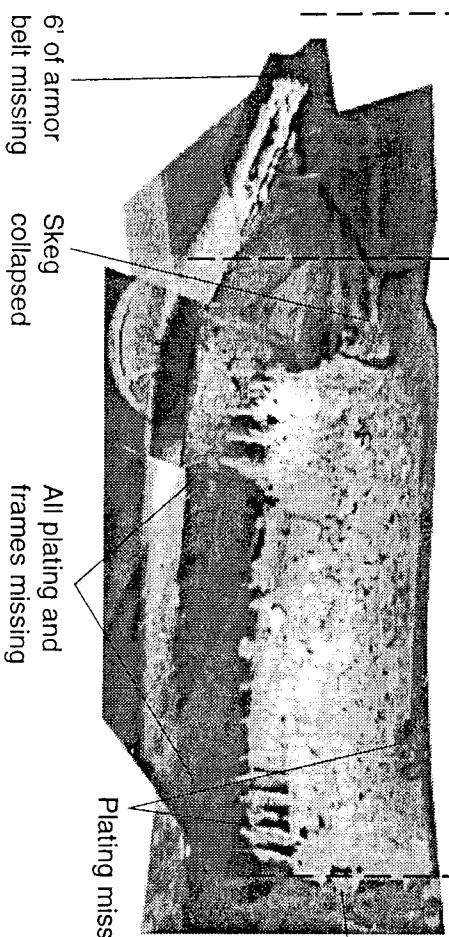
Midship bulk-  
head partially  
collapsed

Figure 7. A Comparison of images of the Monitor's hull, showing recent deterioration in the stern (U.S. Navy)

exhibit similar degradation. In fact, the observed collapse of many of the lower hull frames since 1990, including the midships bulkhead frame, supports NOAA's assumption that the *Monitor's* hull retains very little mechanical strength. Wooden components that made up much of the underlying strength of the upper deck and armor belt are suffering from cellular deterioration and the action of shipworms. The *Monitor* contents include wood, hemp, leather, cloth, brass, bronze and other materials, all of which are deteriorating at different rates. Human intrusion, including anchoring and fishing activities, has also become a significant factor in recent degradation. Although NOAA is well aware of the continuing deterioration of the *Monitor's* hull, the extent of that deterioration since 1991 was not expected. The observed increase in the rate of deterioration does not appear to be the result of the continual slow corrosion of iron but, rather, consists primarily of the periodic collapse or disintegration of hull components as those components reach stress limits.

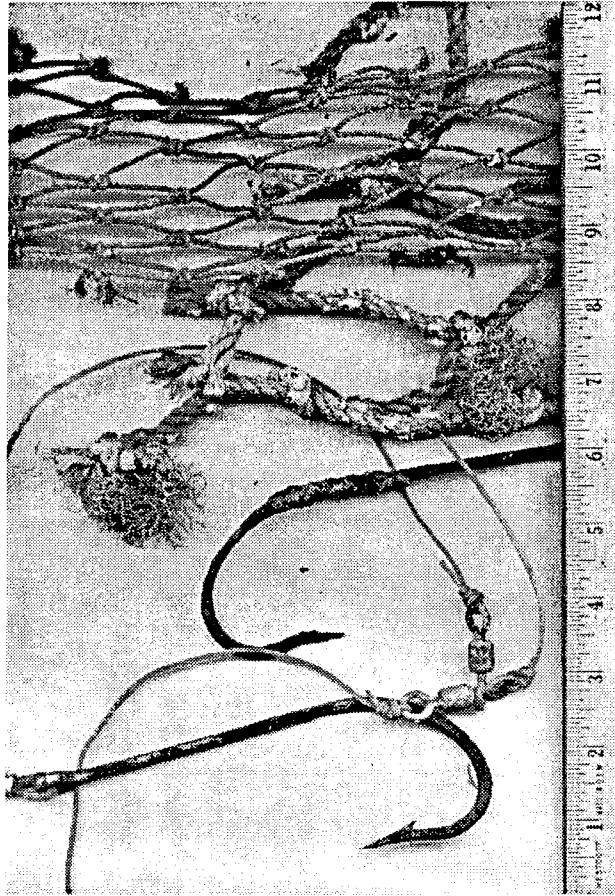
Figure 8. A sample of fishing gear recovered from the Monitor's hull in 1997 (NOAA).

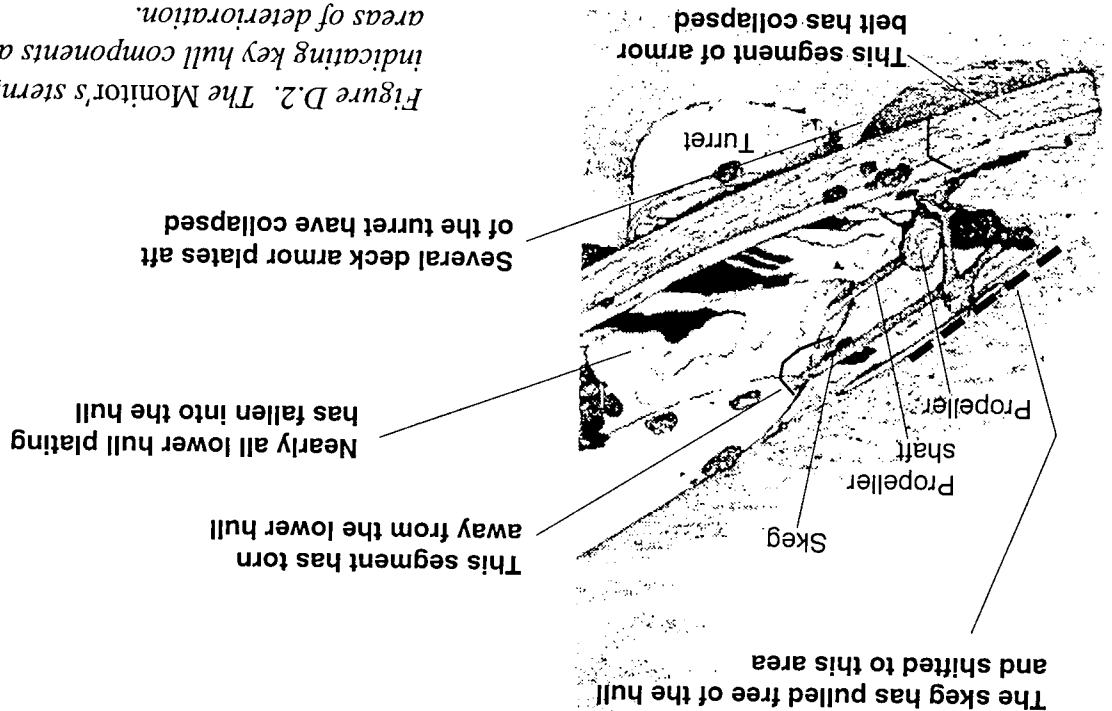
Figure D.2. The Monitor's stern, indicating key hull components and areas of deterioration.

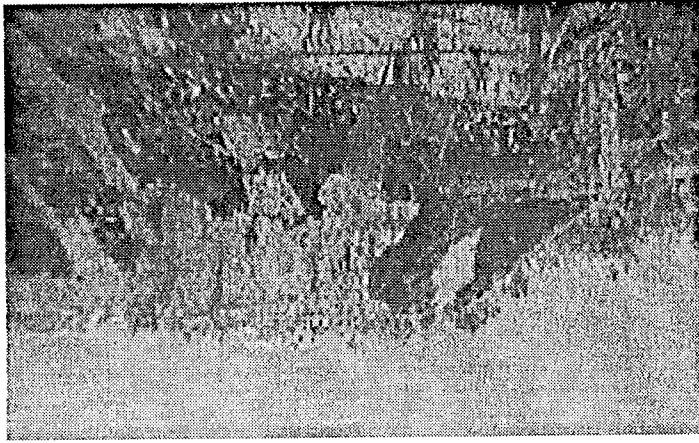
Figure D.5. The skeg and lower hull in 1997, after further displacement.  
(Photo © 1997 Joe Poe, Farb Monitor Expeditions)

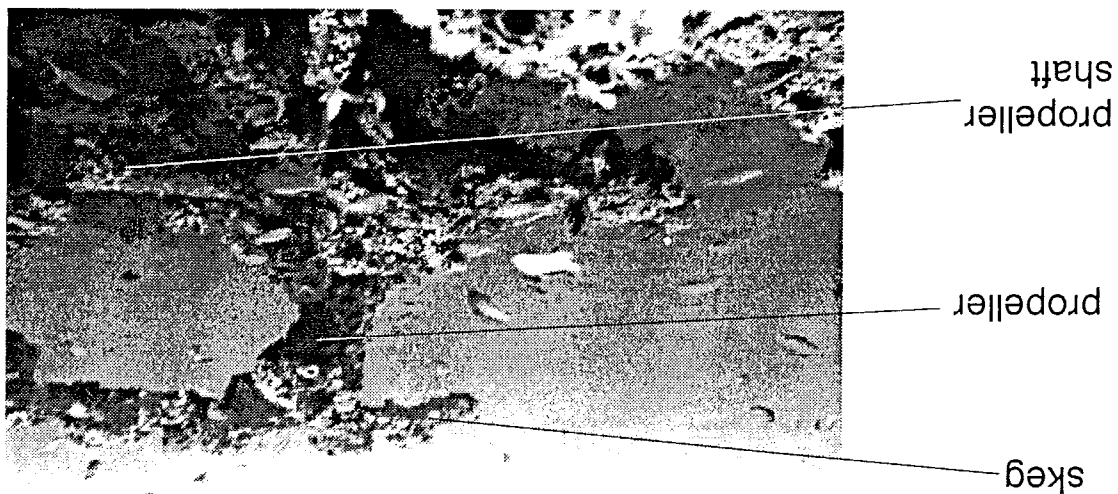
The **skag and propeller** are heavily encrusted with oxidation products and marine growth, making the propeller difficult to recognize. The encrustations will make removal of the propeller difficult.

Figure D.6. The skag, propeller and propeller shaft in 1990, before displacement. (Photo © 1990 Farb Monitor Expeditions)

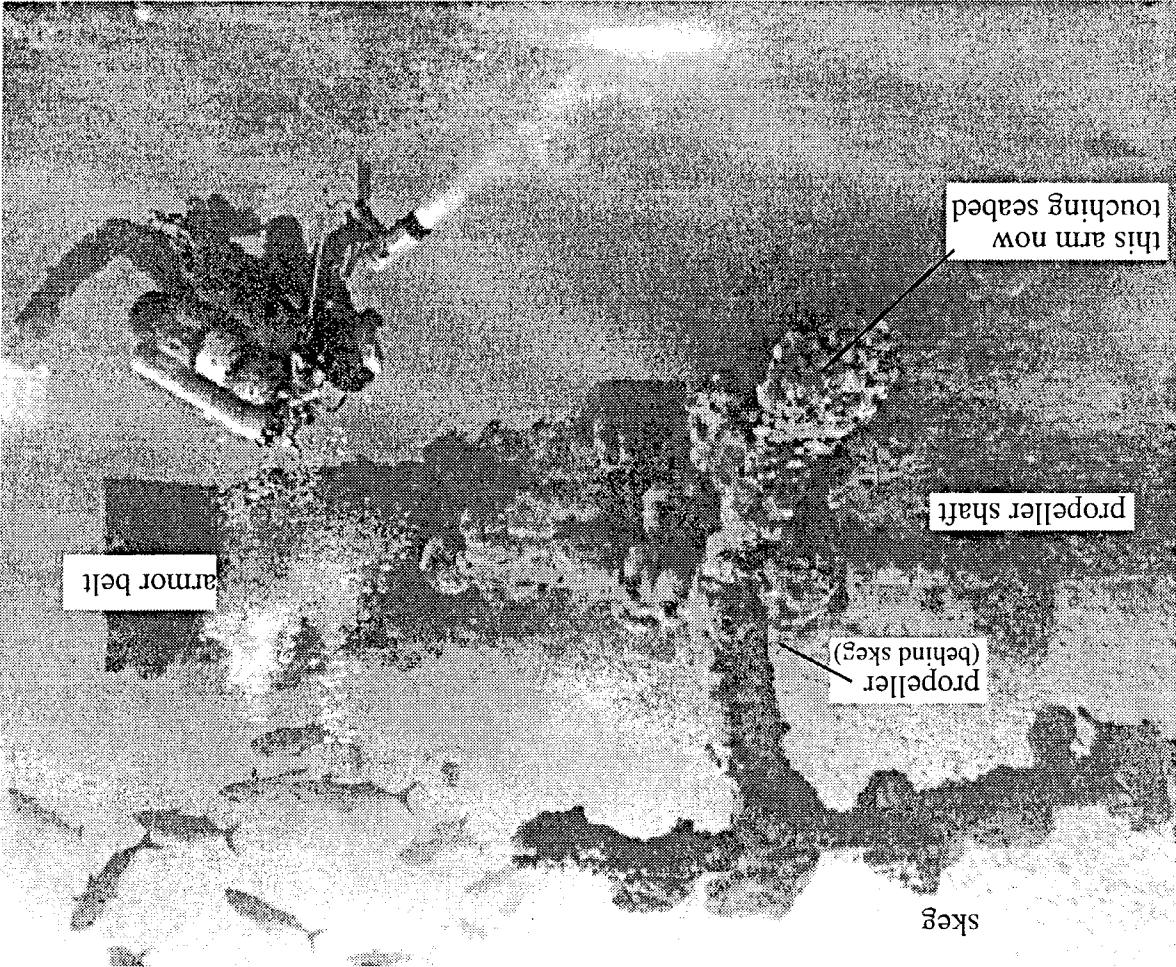
The above view of the stern was taken from near the centerline at the very stern end of the hull, clearly showing how the stern is suspended above the bottom and illustrating the damage to the hull in this area. Since 1990, when this photograph was taken, the skeg and its support have slowly fallen toward the south (toward the camera), rotating counter-clockwise as they fell. The skeg support arm nearest the camera has rotated downwards until it now rests on hull debris on the seabed. Although this arm now seems to be providing some support for the skeg, the skeg appears to remain unstable, slipping further to the side and placing additional stress on the already-damaged stern.

Figure D.8. A view of the skeg, propeller and propeller shaft facing north (port); this photograph, taken in 1990, shows the skeg before displacement. (Photo © 1990 Gary Gentile)

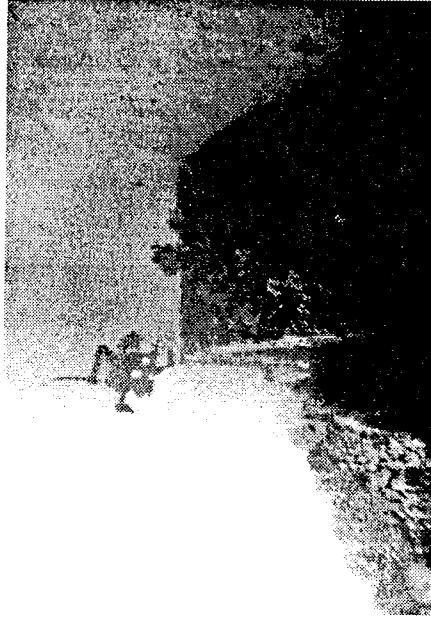
Turret has filled with silt. The weight of the hull resting on the turret has caused the deck to fracture and the turret to push through the deck. Lumps of coal on the turret floor indicate that material is falling through the deck from the engineering space above.

Figure D.10. View of the interface between the turret and armor belt, looking forward, showing that the area of contact is small and that the weight of the hull pressing against the turret has created a hole in the deck. (Photo © 1997 Joe Poe, Farb Monitor Expeditions)

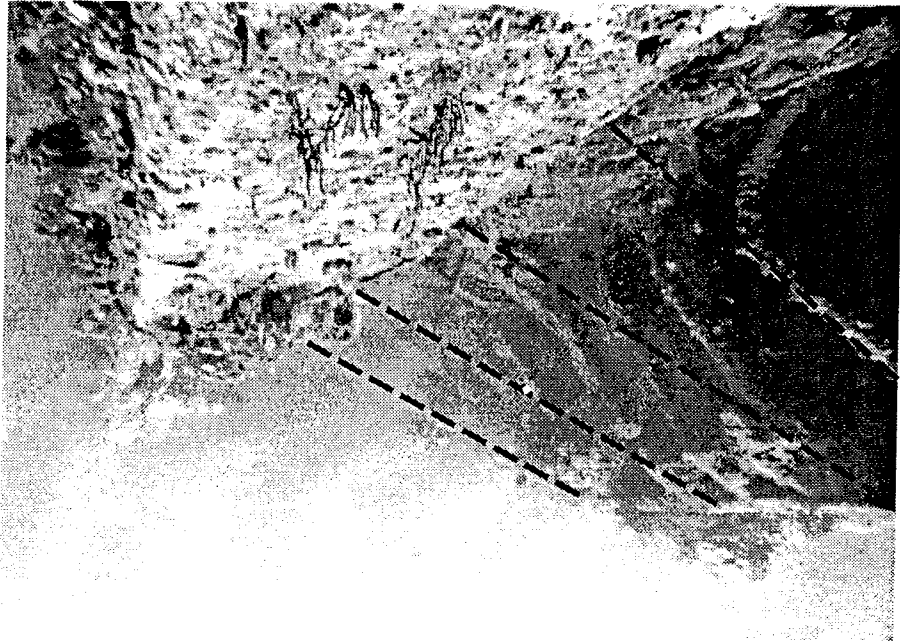
The lower hull forward of the midships bulkhead has collapsed; the portion of lower hull aft of the bulkhead has sagged and now rests on the boilers and machinery which, in turn, appear to have settled sufficiently to be supported by the sand beneath the hull. A number of plates are missing from the top and sloping sides of this section, as are many of the iron frames. Immediately aft of the turret on the port side, a large section of deck, including plates and the material to which they were attached, has separated from the underlying structure and can be seen hanging from the wreck. Although many of the plates remain attached to the wood backing material, displaced hull plates can be seen in the sand near the section of separated deck. A six-foot section of the stern end of the port armor belt has disintegrated since the wreck was first documented in 1974. An examination of the back side of the armor belt revealed that in many places the wood to which the plates are attached has almost completely disappeared.

Figure D.9. View of the lower hull and armor belt, looking forward, showing damaged and missing supports and missing plating; dashed lines show extent of original hull structure. (Photo © 1997 Joe Poe, Farb Monitor Expeditions)
